TS 2004 NDT Workshop

Ground Penetrating Radar for Pavement Investigations

Tom Scullion

Texas Transportation Institute

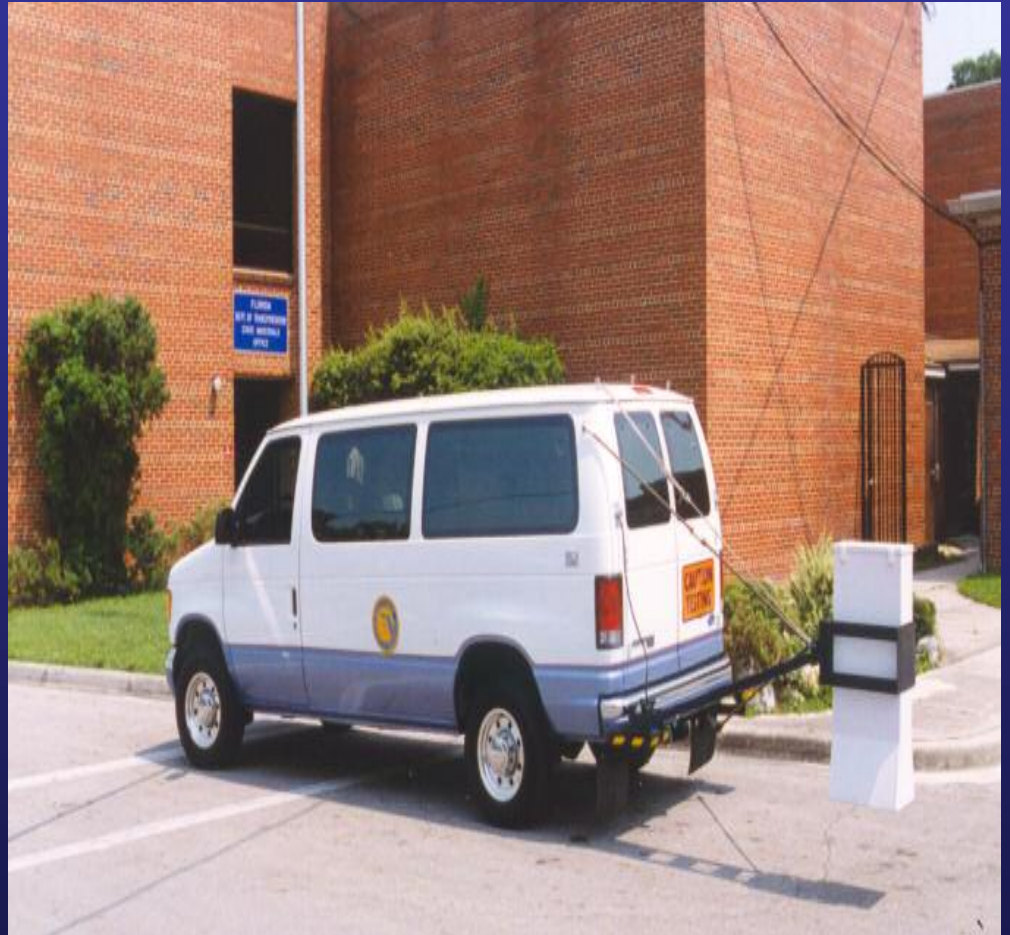
Pulse Radar Antenna

Finland's GPR systems

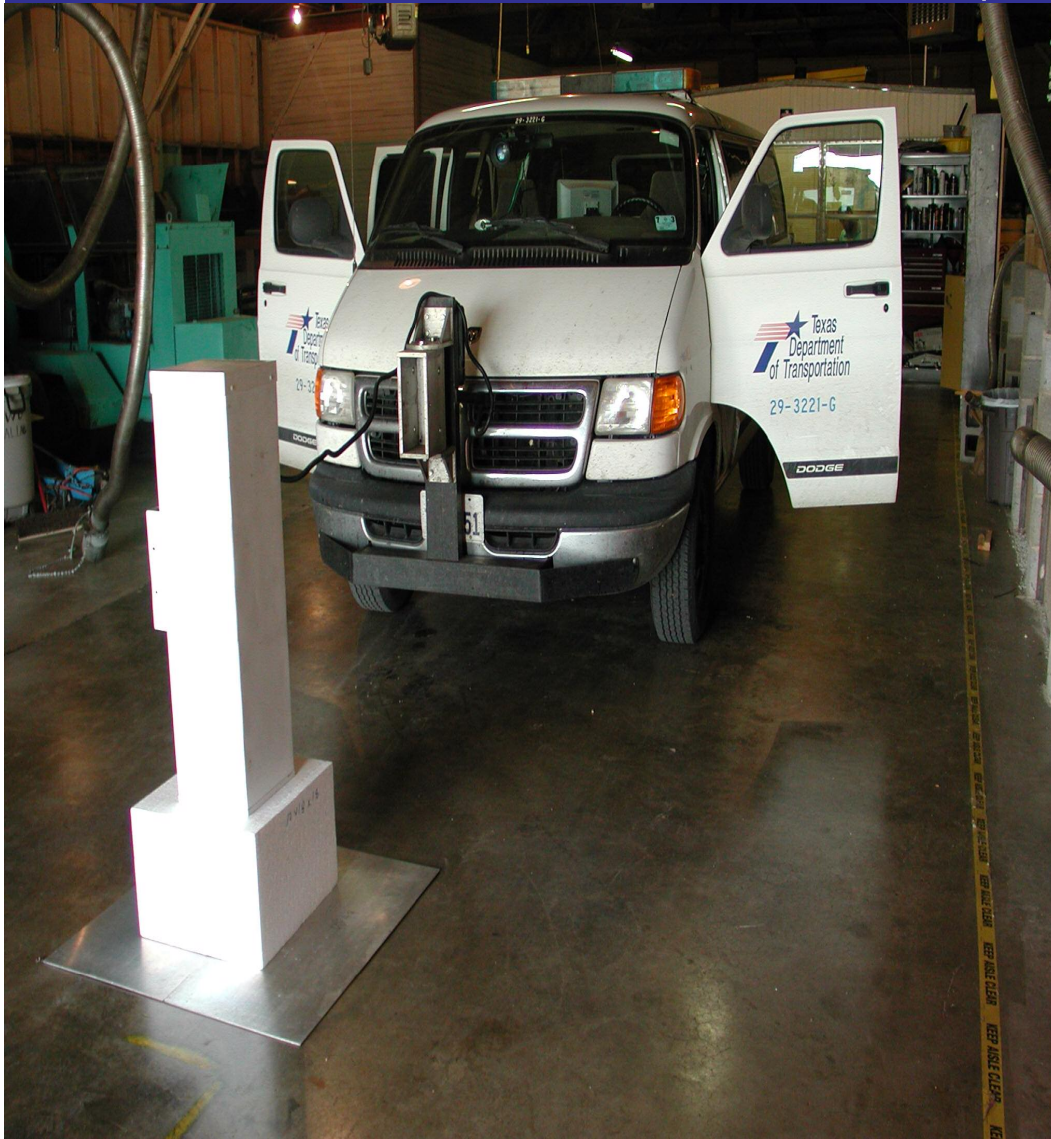
TxDOT's Specification Tests

Annual Recalibrations (completed May 2003)

Standard tests include

- Noise/Signal < 5%
- Signal stability < 1%
- Long term Stab < 3%
- Concrete Penetration
- System Calibration factors determined

6 Units tested (May 2003)

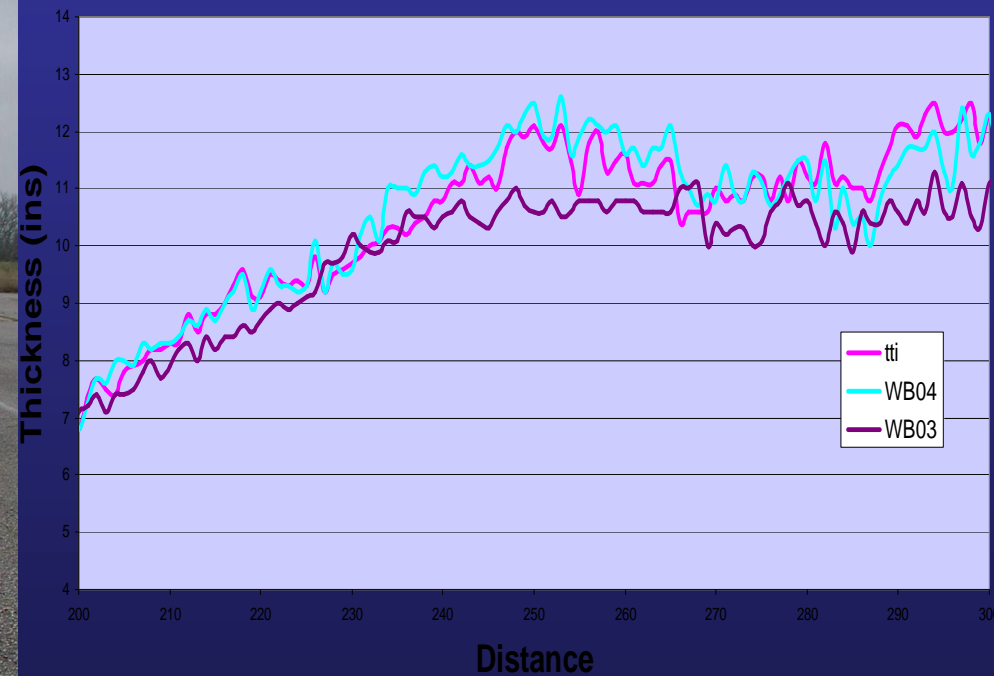
Base Thickness - Annex

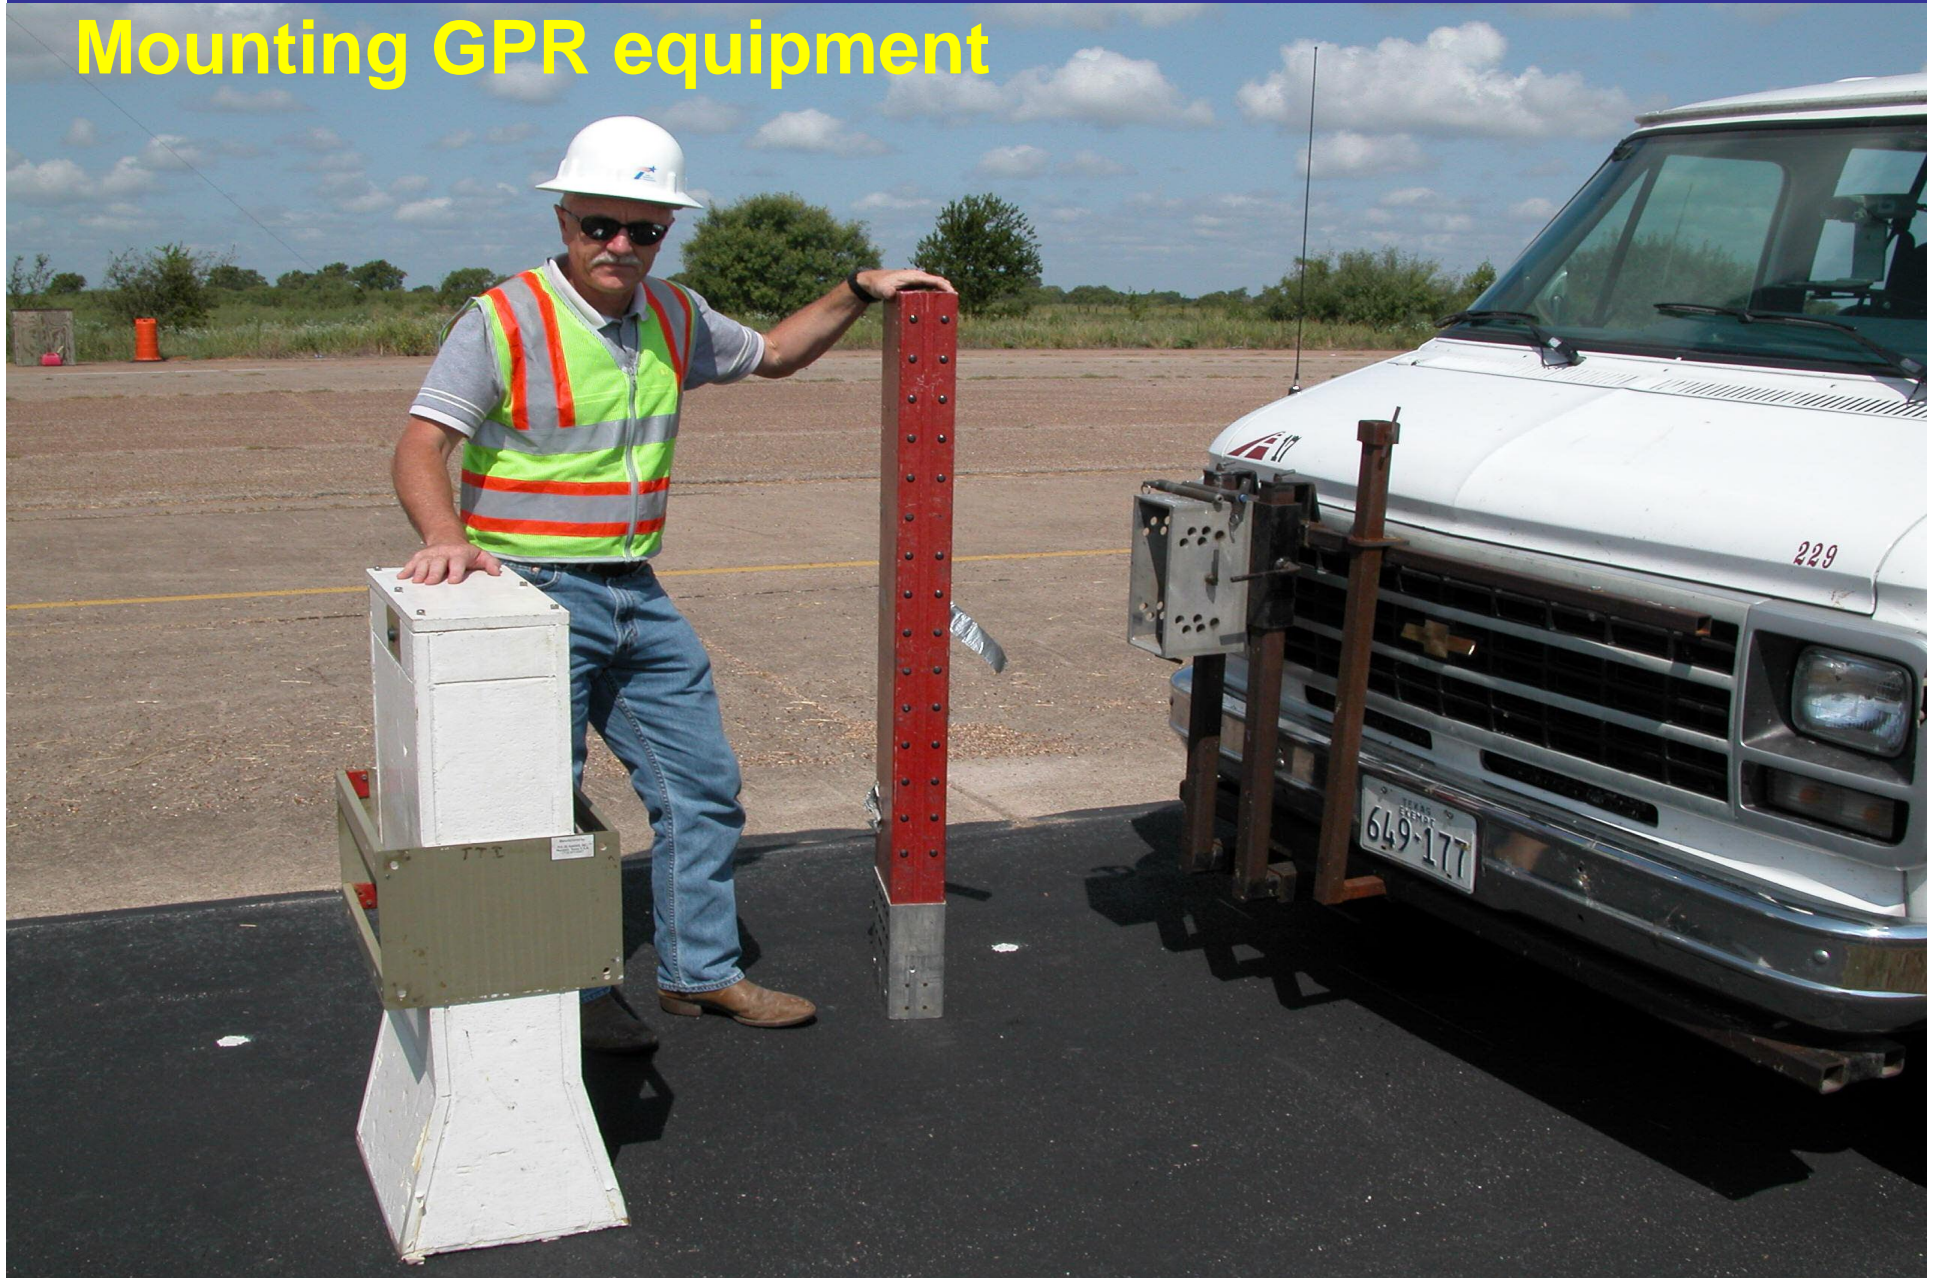
Mounting GPR equipment

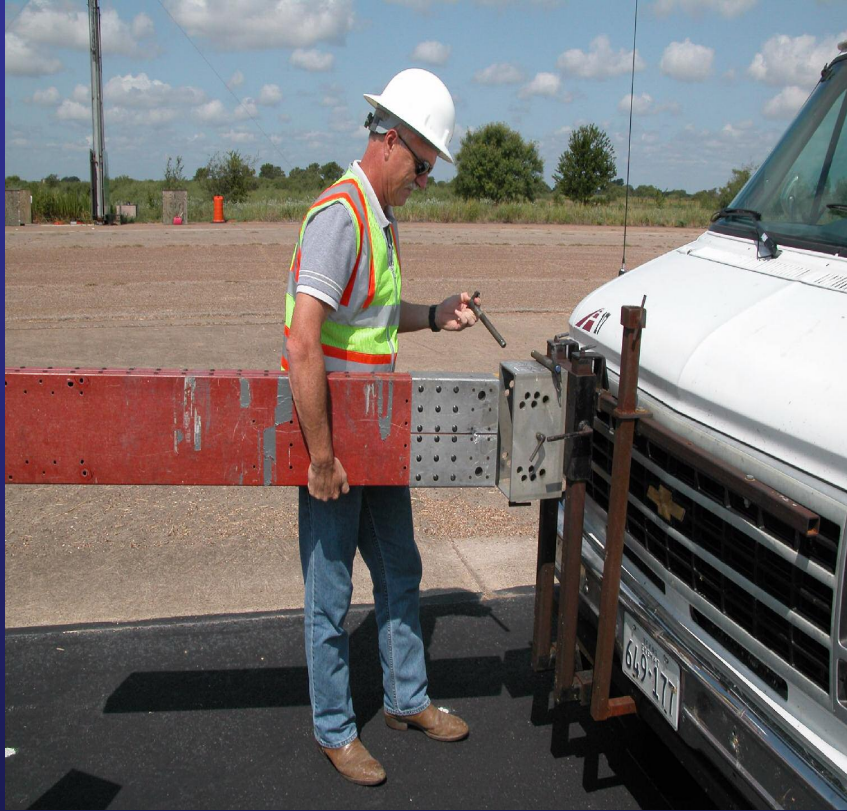
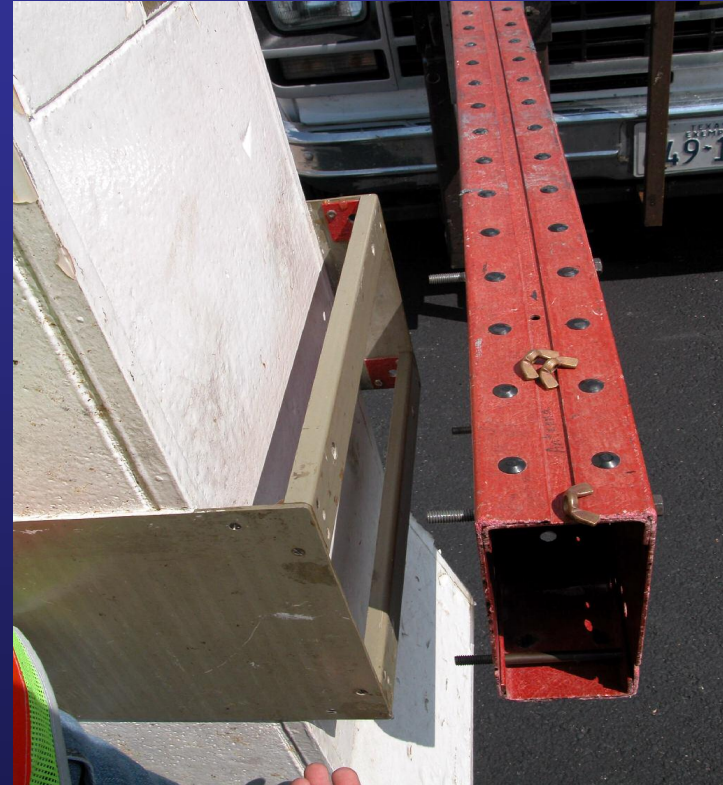
Fiberglass Boom

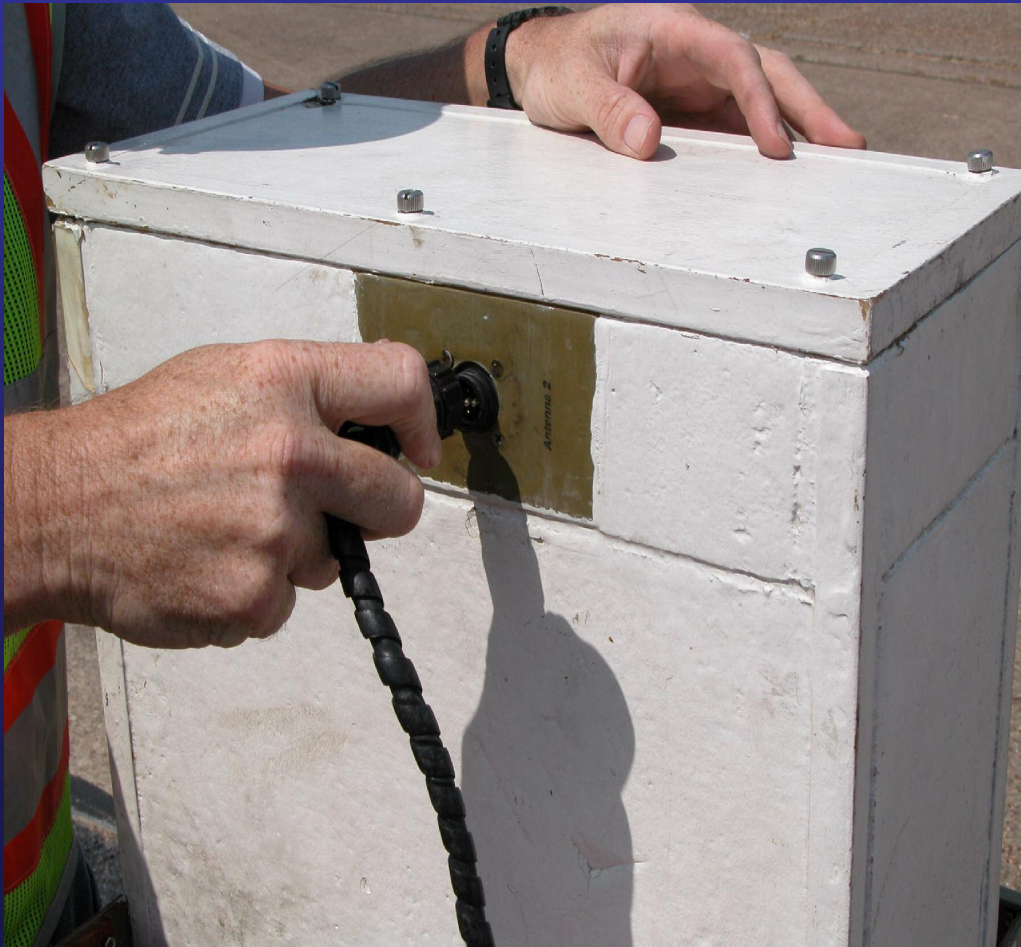
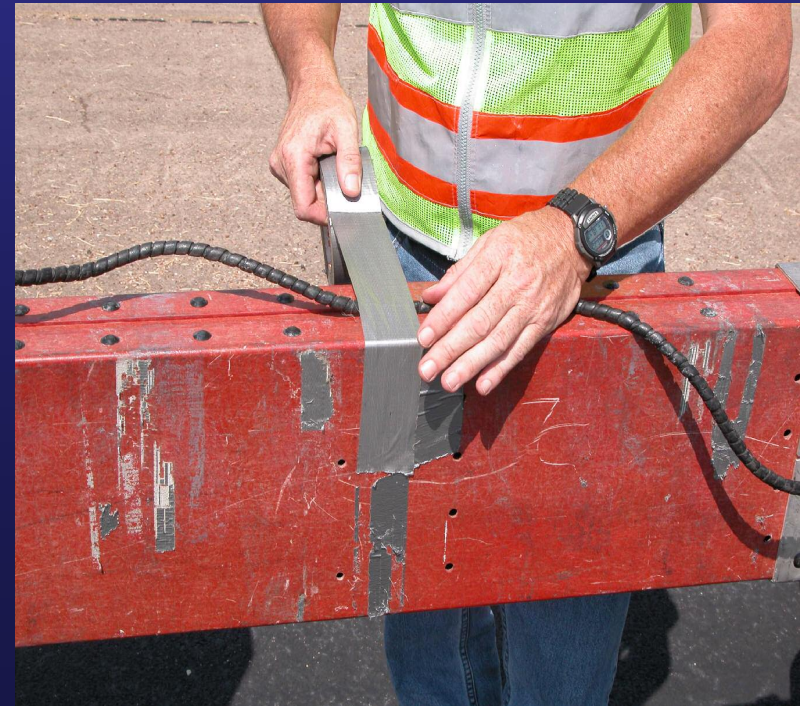
Cable connections

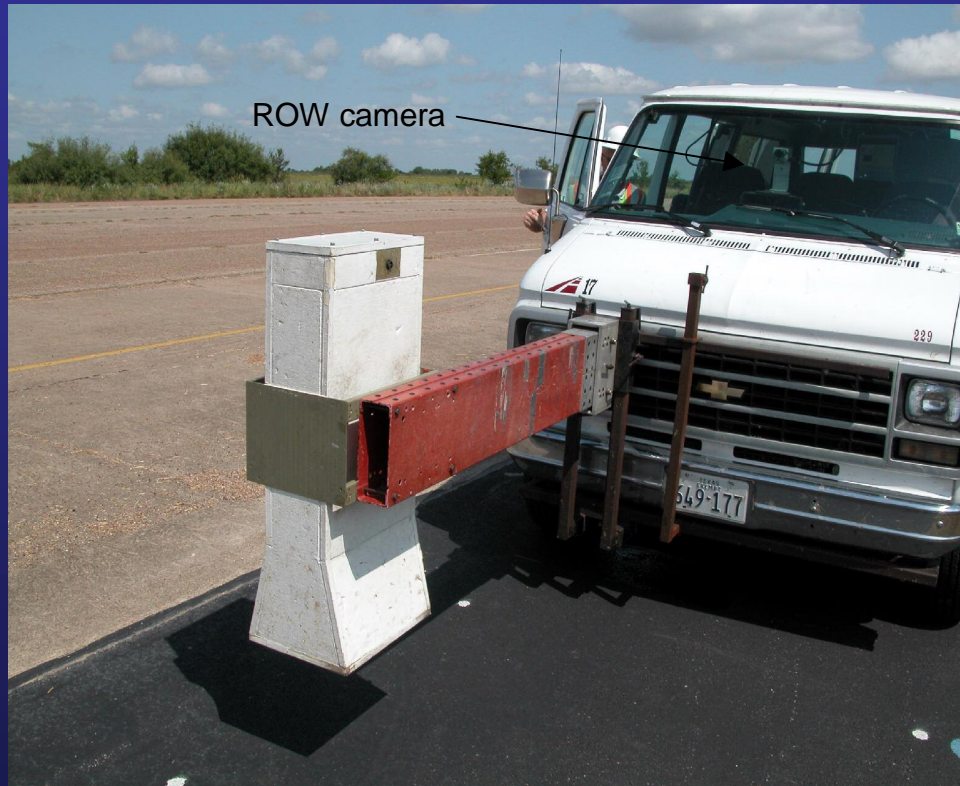
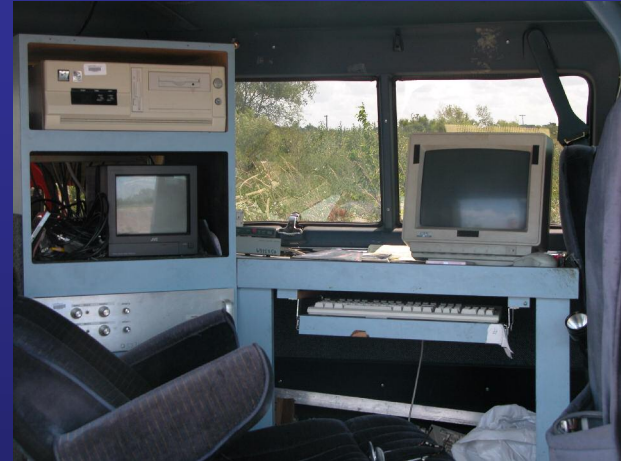
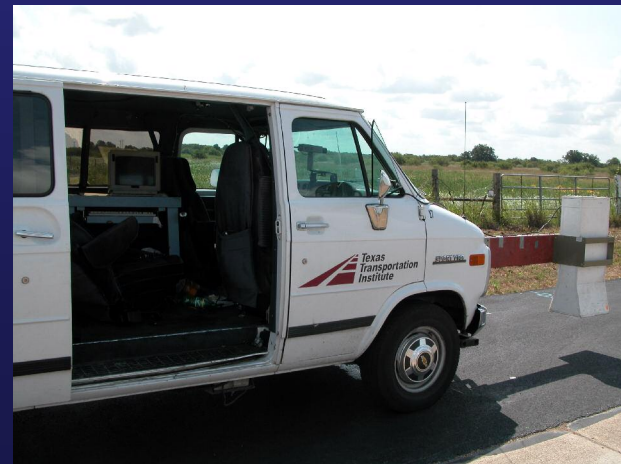
Final Assembly 15 minute warm up

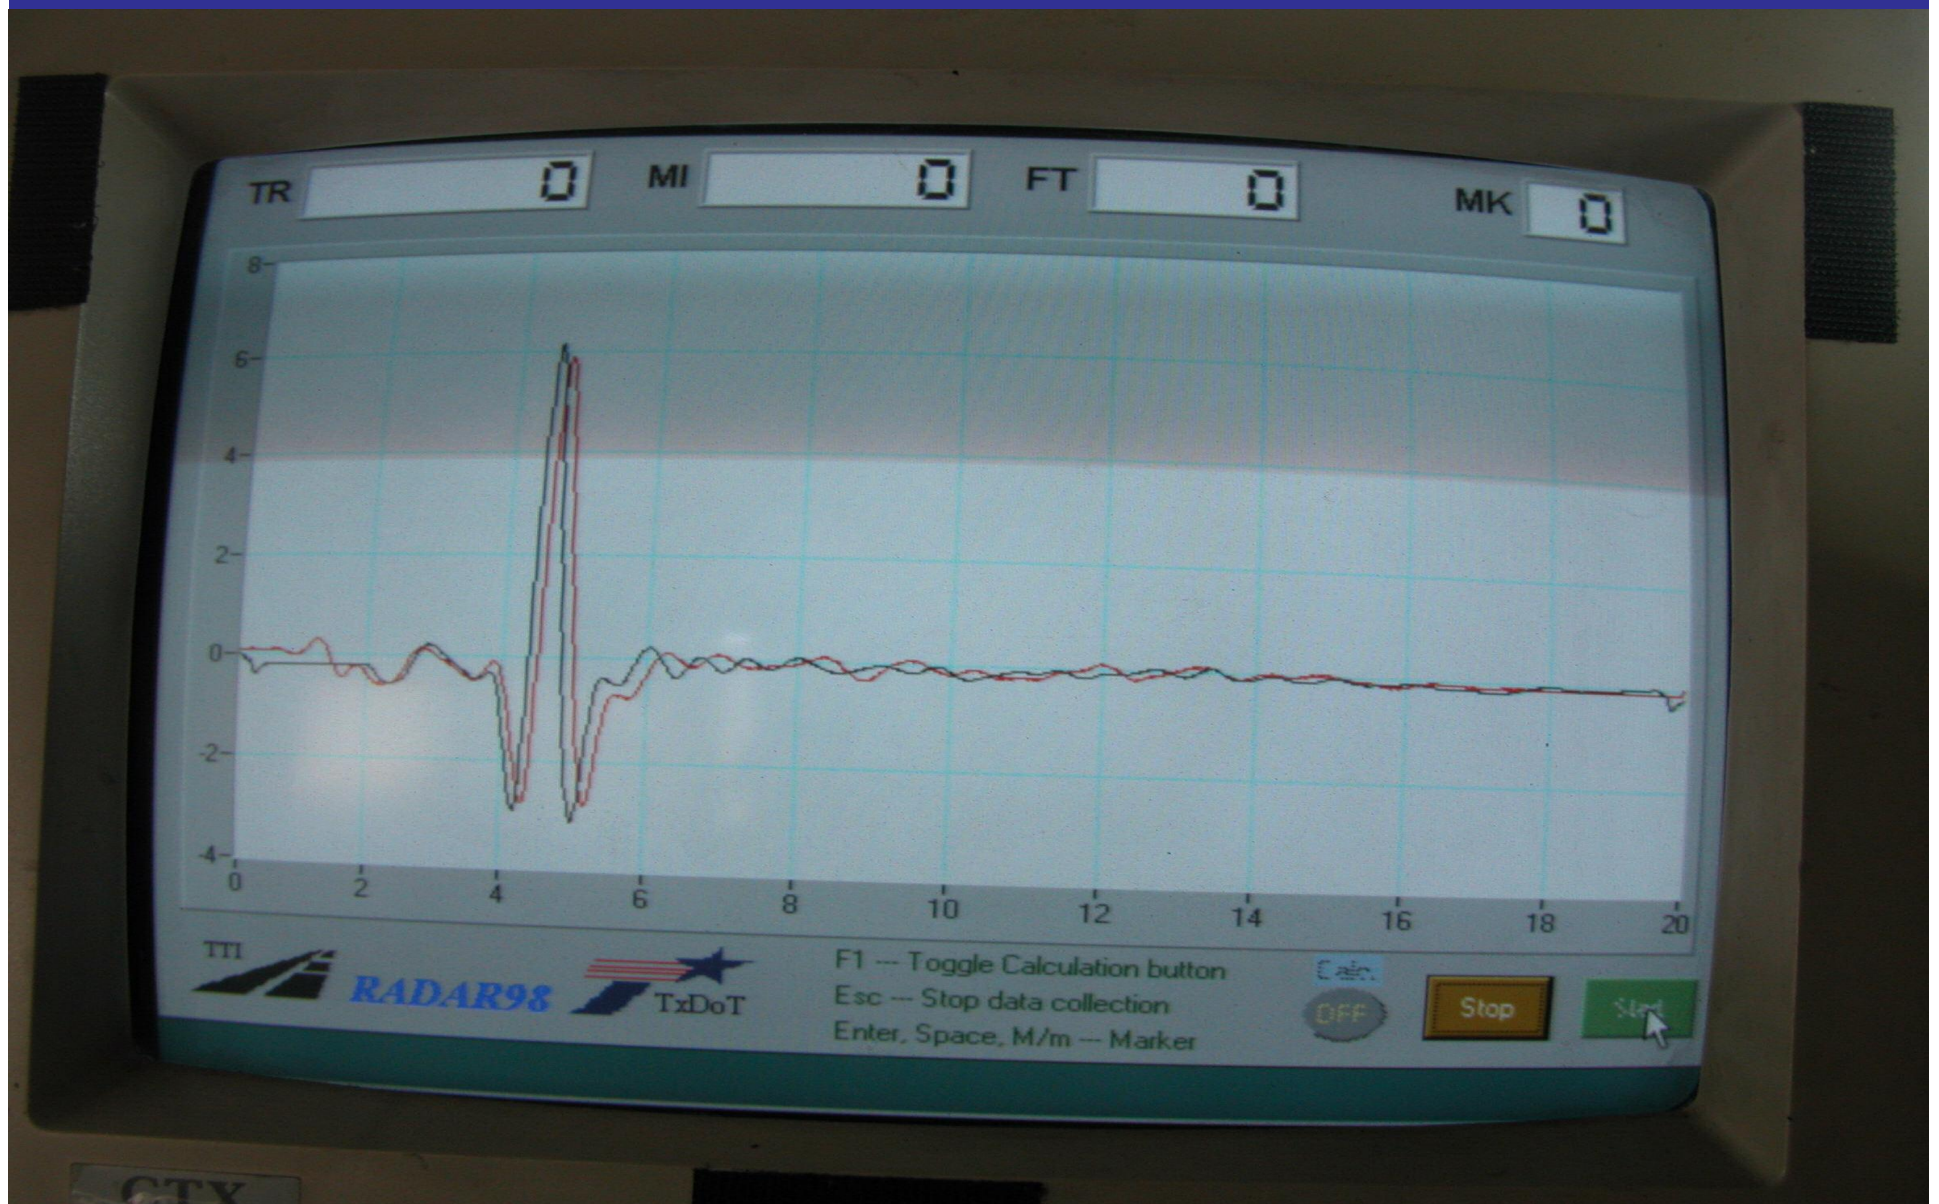
Step 1 Data Acquisition

System Check

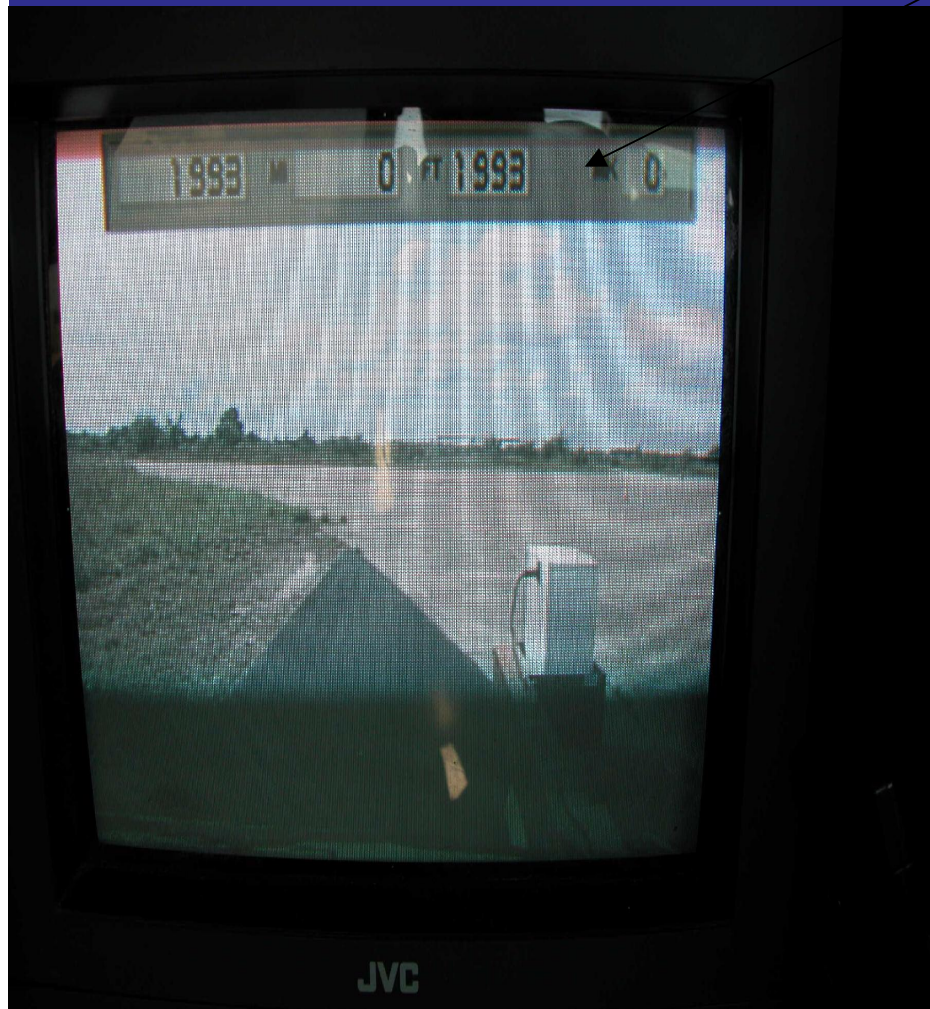
Operators view during data collection

same header information

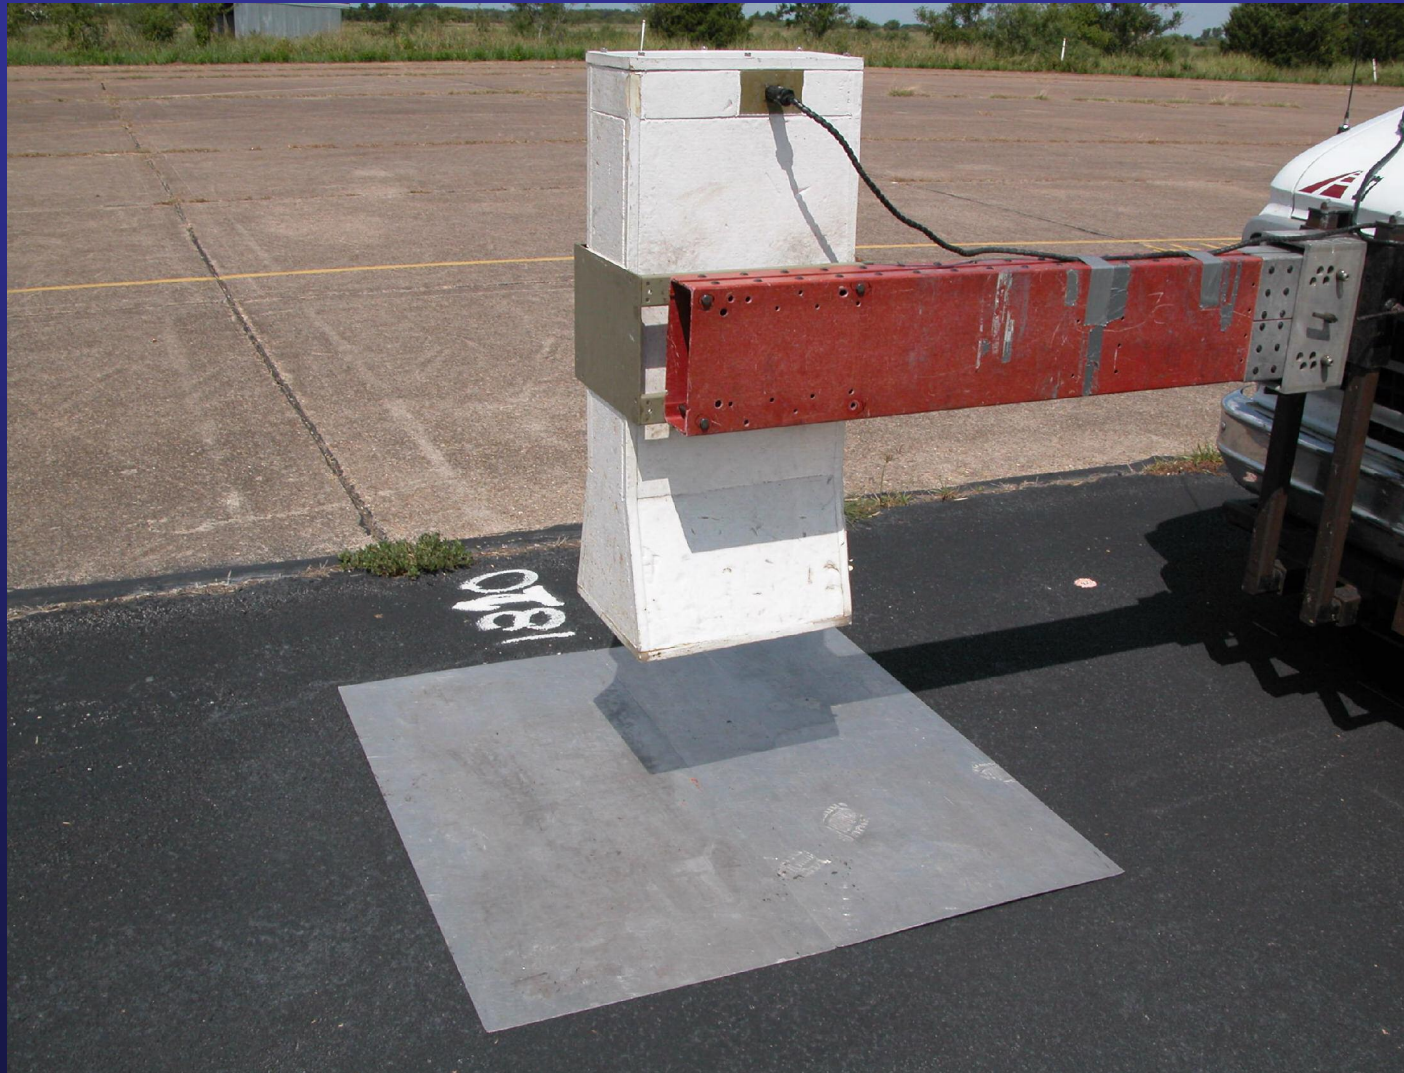
Metal Plate Test at end of run

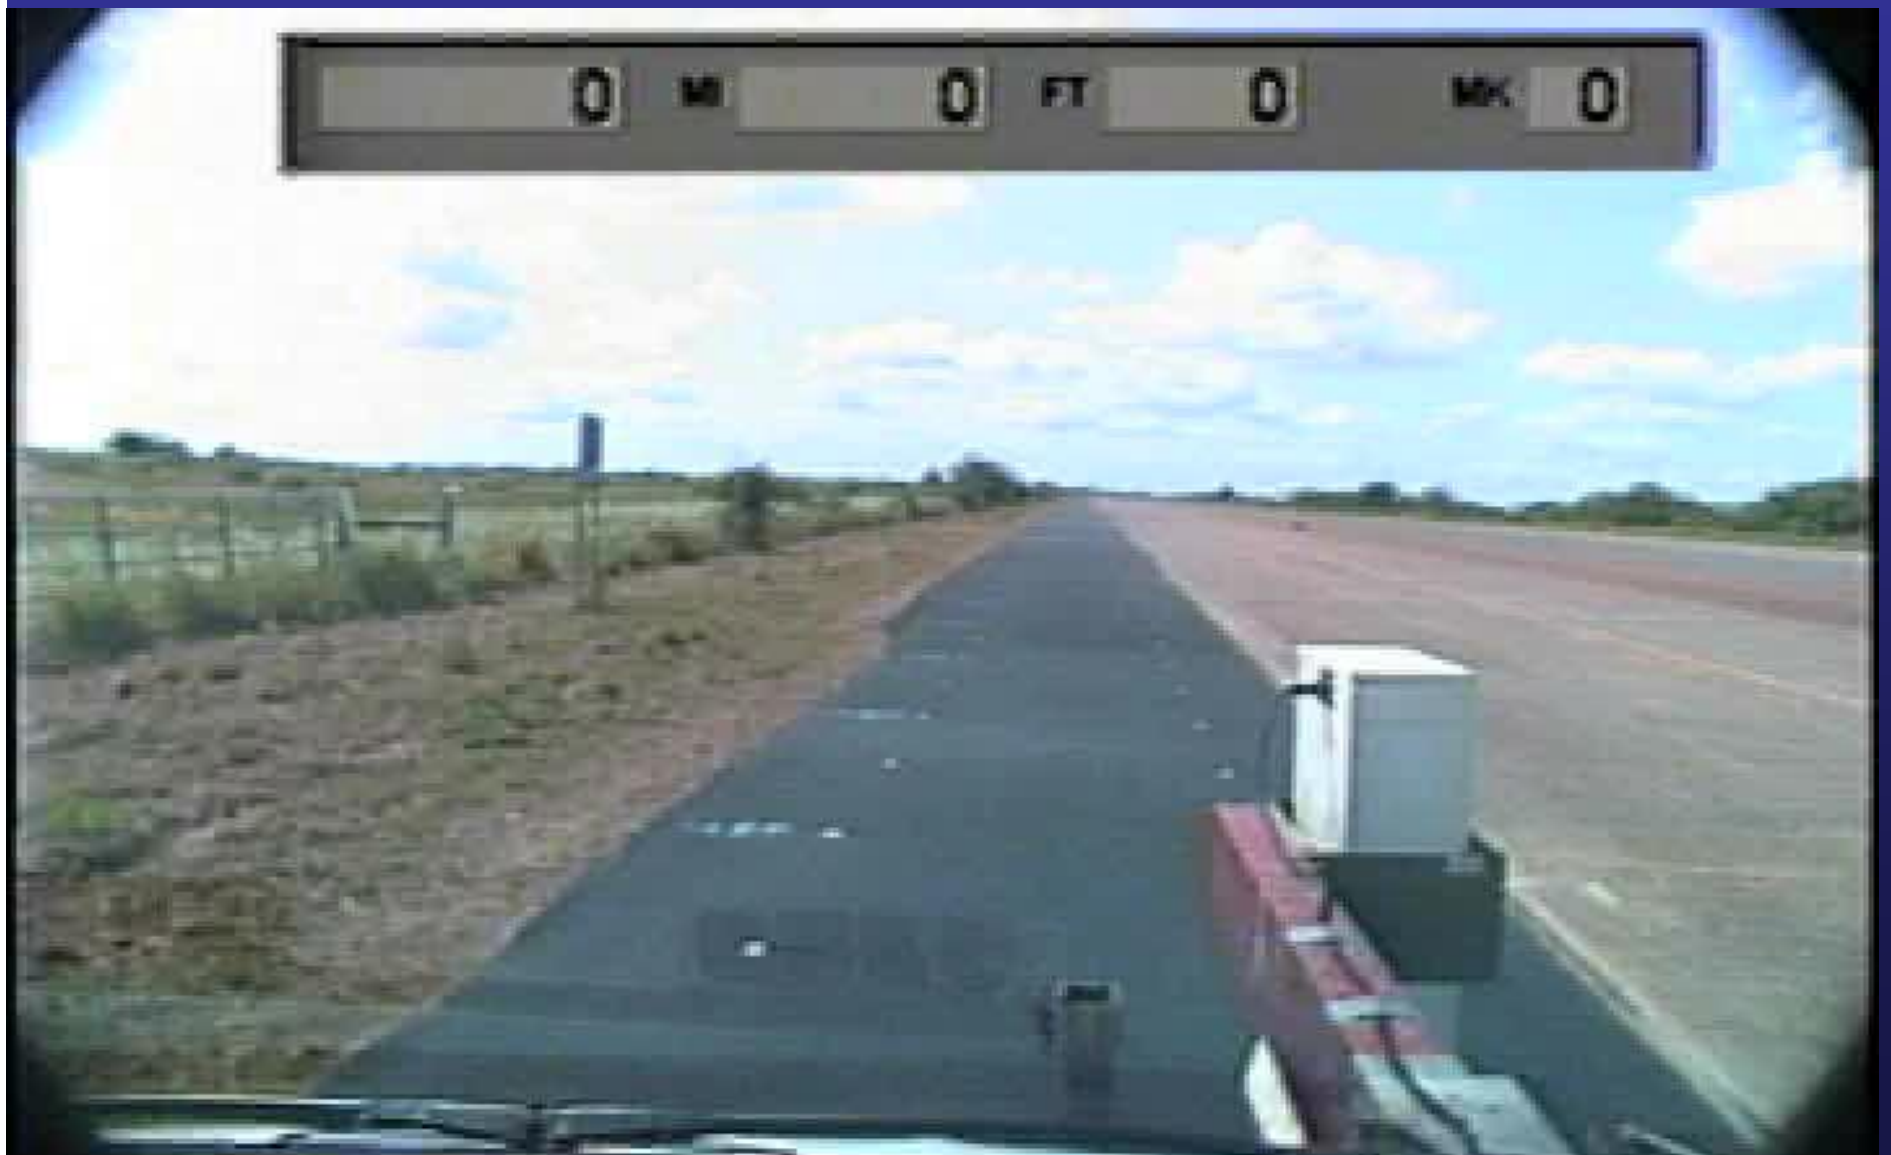
TTI's Rut/Ride Calibration section

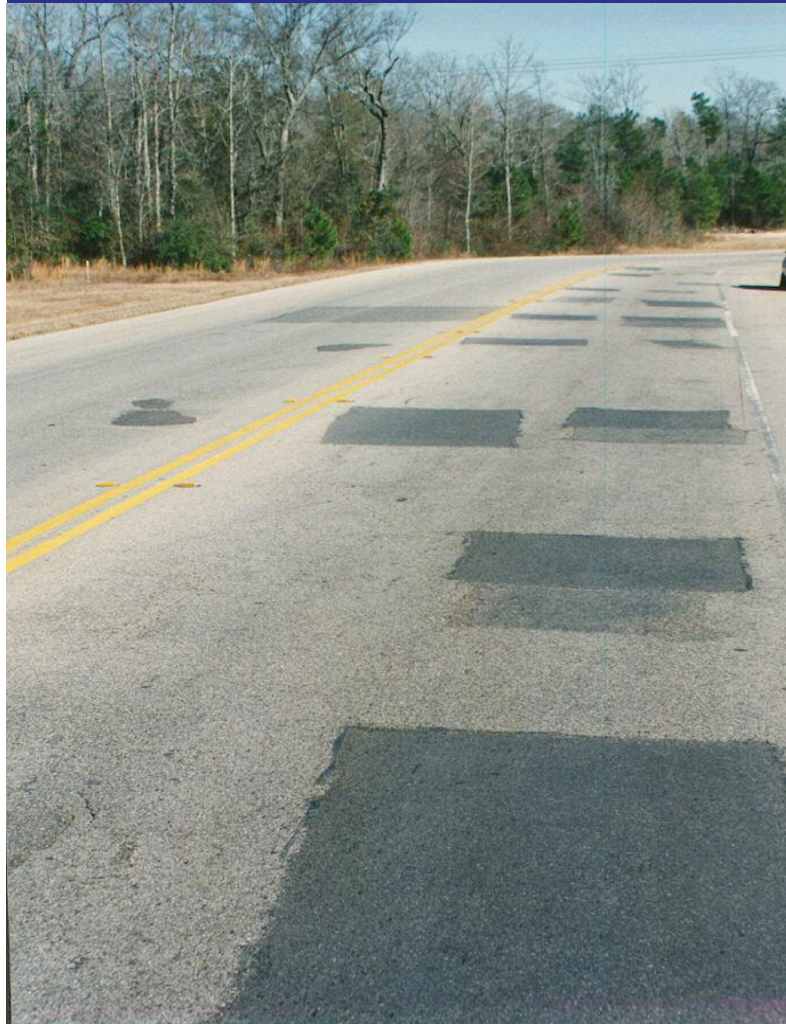
Detecting Base Moisture problems with GPR

3 Year old CTB
Sandstone
(Houston)

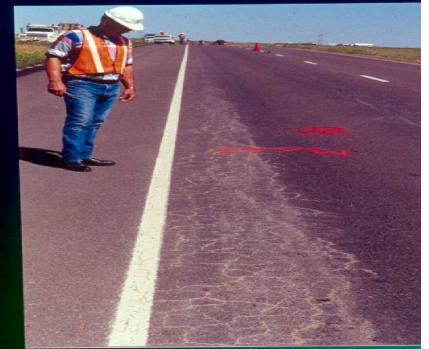
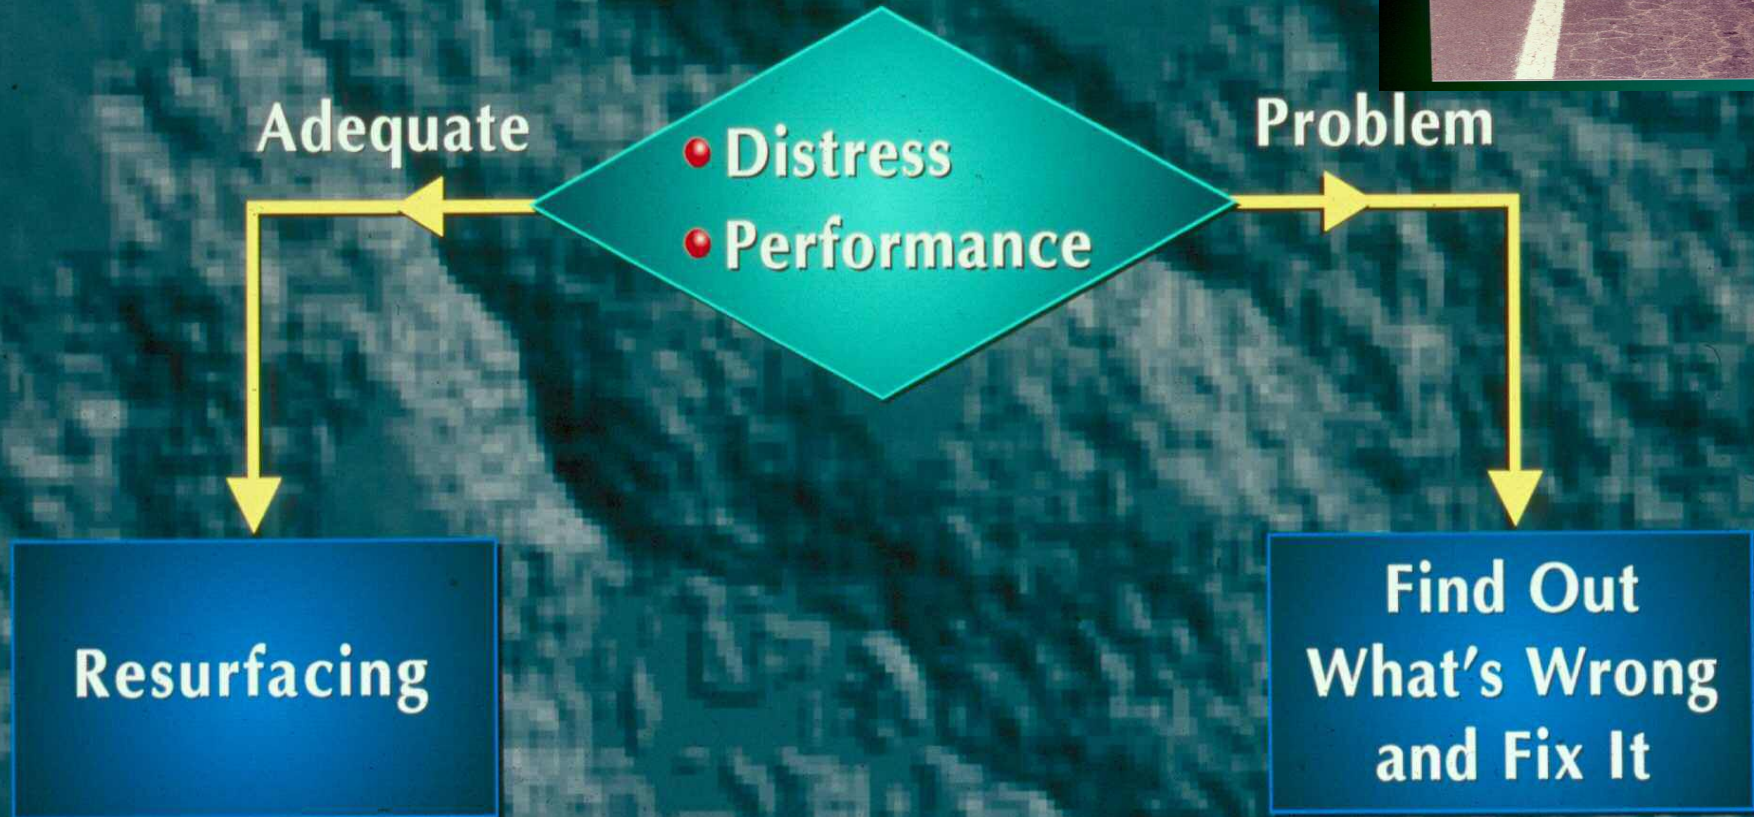
FORENSIC INVESTIGATION U.S. 28
RECYCLED BASE (1 YEAR OLD)

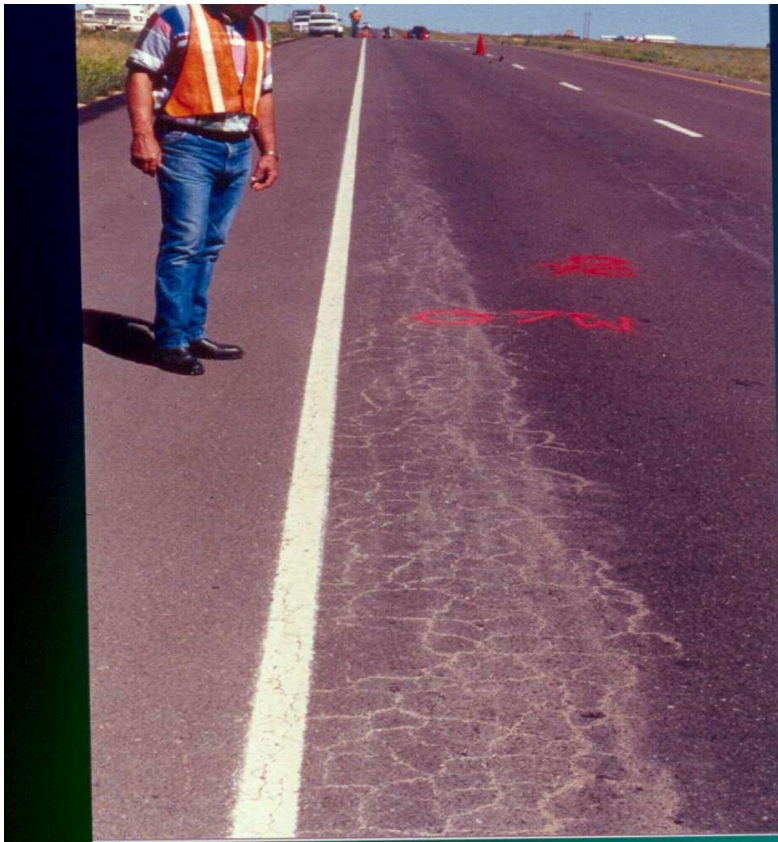
Alligator 1 US 287

Causes of Failure

**Lack of bond between
HMA layers**

Burnt binder in top layer

Not a base problem

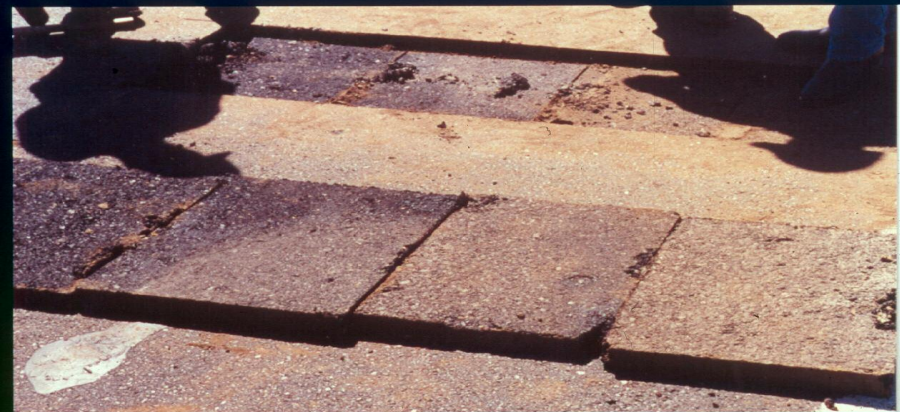
FORENSIC INVESTIGATION U.S. 287 RESULTS FROM SHALLOW TRENCHING

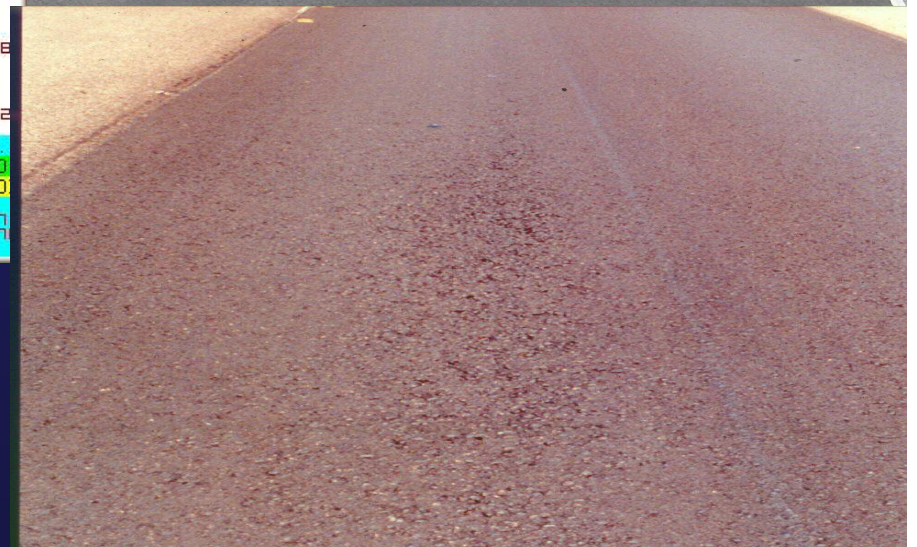
Longitudinal Joint Density
